Menindee Incident - water quality update 23 March 2023

Water quality update for Menindee Incident

Darling River and Menindee Lakes

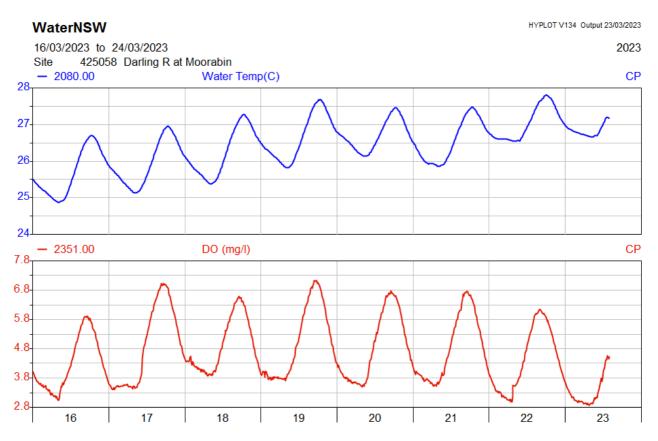
Discharge in the Darling River and Tallyawalka Creek at Wilcannia is 1,316 and 962 ML/day respectively. Dissolved oxygen levels at Wilcannia are dropping below the 4 mg/L safe threshold for fish health over night but improving above 6 mg/L during the day (Figure 1). As a general guide, native fish and other large aquatic organisms require at least 2 mg/L of dissolved oxygen to survive but may begin to suffer if levels are below 4 to 5 mg/L for prolonged periods.

Figure 1: Continuous dissolved oxygen (mg/L) and water temperature (°C) in the Darling River at Wilcannia (Moorabin) The continuous dissolved oxygen monitorng site in the upper reaches of Lake Wetherell at Nelia Gaari is also showing oxygen is dropping to critical levels overnight and then recovering during the day (Figure 2).

Dissolved oxygen levels drop overnight when respiration (microbes and animals breathing oxygen) outpaces oxygen replenishment (photosynthesis from aquatic plants and algae) that occurs during the day.

Water temperature at Wilcannia has stabilised at around 27°C. The amount of dissolved oxygen water can hold decreases with increasing water temperature which can add additional stress to fish that may already be struggling.

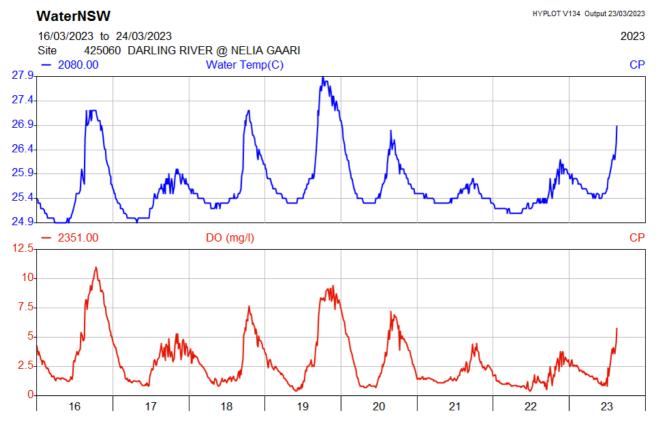
Figure 2: Continuous dissolved oxygen (mg/L) and water temperature (°C) in the Darling River at Nelia Gaari

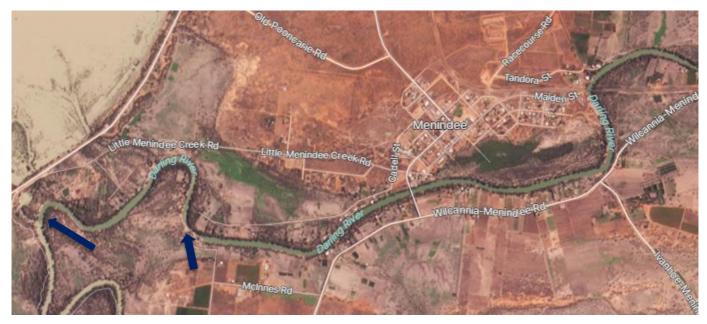
Planet satellite imagery taken on 19 March showed an accumulation of dead fish upstream of the junction of the Darling River and Menindee Creek. Figure 3 is an image taken on 21 March which shows the accumulation of dead fish has dispersed. There still appears to be dead fish concentrating along the banks in some areas.

Figure 3: Planet satellite image from 21 March 2023 showing the accumulation of dead fish that was at the junction of the Darling River and Menindee Creek has been dispersed

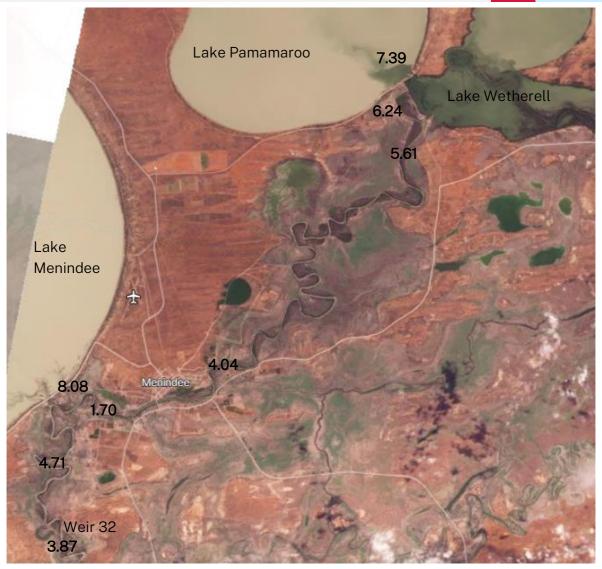
Figure 4 is a Planet satellite image showing the Darling River and Menindee Lakes at Menindee on 22 March. Dissolved oxygen monitoring results (mg/L) collected near the water surface by WaterNSW 22 March are shown on Figure 4. Figure 5 shows the dissolved oxygen data collected at the same sites on 23 March.

Figure 4: Planet satellite image – Image 21 March. Dissolved oxygen data collected 22 March (mg/L)

Dissolved oxygen in the water being released from lakes Pamamaroo and Menindee is above the safe threshold for fish health (4 mg/L).

The lowest readings are in the Darling River from the railway bridge down to the junction of the Darling River and Menindee Creek. These low dissolved oxygen results indicate that there is still a risk of further fish deaths in this area and downstream. The readings taken near the surface indicate there is some oxygen replenishment from the atmosphere. However, readings taken deeper in the water column show oxygen levels quickly drop below 2 mg/L at around 50 cm.

The Pamamaroo inlet regulator has been opened to allow the water levels between lakes Wetherell and Pamamaroo to even out. The green coloured water in the imagery can be seen pushing out into the turbid water of Lake Pamamaroo. Ongoing monitoring will identify if this low oxygen water is once again being drawn into the Pamamaroo outlet.

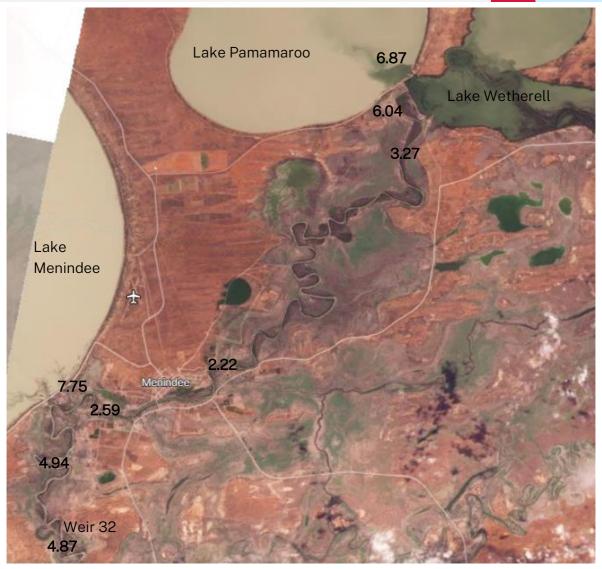
Figure 5: Planet satellite image – Image 21 March. Dissolved oxygen data collected 23 March (mg/L)

Monitoring is showing that releases from Lake Menindee are diluting the low oxygen water coming down the Darling River through Menindee town. It is also showing that turbulence from the high flow velocity is mixing oxygen through the whole water column. The dissolved oxygen results from upstream of Weir 32 are higher than the readings from the continuous sensor at the gauging station (Figure 6). The sensor at Weir 32 is set at a fixed depth near the bottom of the weir pool. Oxygen levels can be higher near the water surface than at the very bottom of pools.

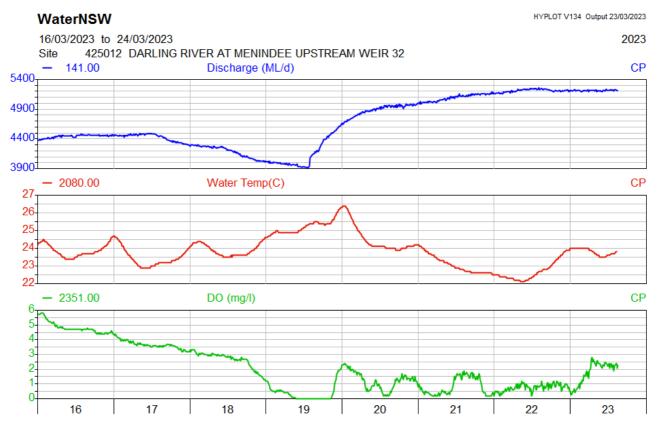
Figure 6: Continuous discharge (ML/day), dissolved oxygen (mg/L) and water temperature (°C) in the Darling River at Weir 32

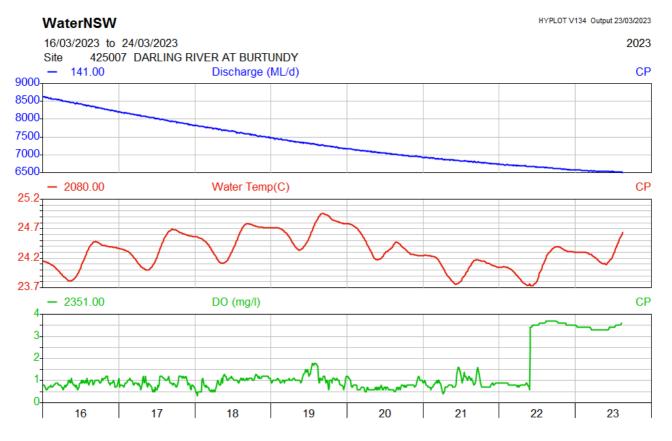
Results from the continuous dissolved oxygen sensor at Burtundy had been low. Routine maintenance resulted in dissolved oxygen readings jumping up to around 3.5 mg/L (Figure 7). These readings are more in line with data collected near the water surface with hand held meters. However, results through this stretch of the lower Darling River are still below the safer level for fish health of 4 mg/L.

Figure 7: Continuous discharge (ML/day), dissolved oxygen (mg/L), water temperature (°C) in the Darling River at Burtundy

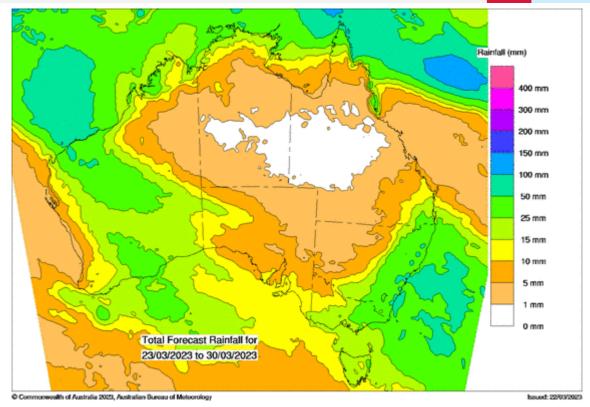
The Bureau of Meteorology 8-day total rain forecast (23 to 30 March) indicates very light rainfall in western NSW with higher falls along the coast (Figure 8). Forecast is for maximum air temperatures at Menindee to remain around 30°C over the weekend and decrease to the low 20's early next (Figure 9). There are no heatwave conditions forecast by the Bureau of Meteorology.

Figure 8: Bureau of Meteorology 8-day total rain forecast (23 to 30 March)
