# Murray Darling Basin – water quality and dissolved oxygen results

Multiple agencies are undertaking water quality monitoring to review dissolved oxygen conditions across NSW, identify potential risks to ecological communities, implement mitigating measures and respond to the mass fish death event in the Darling River. This update provides a summary of information collected up to 23 August 2023.

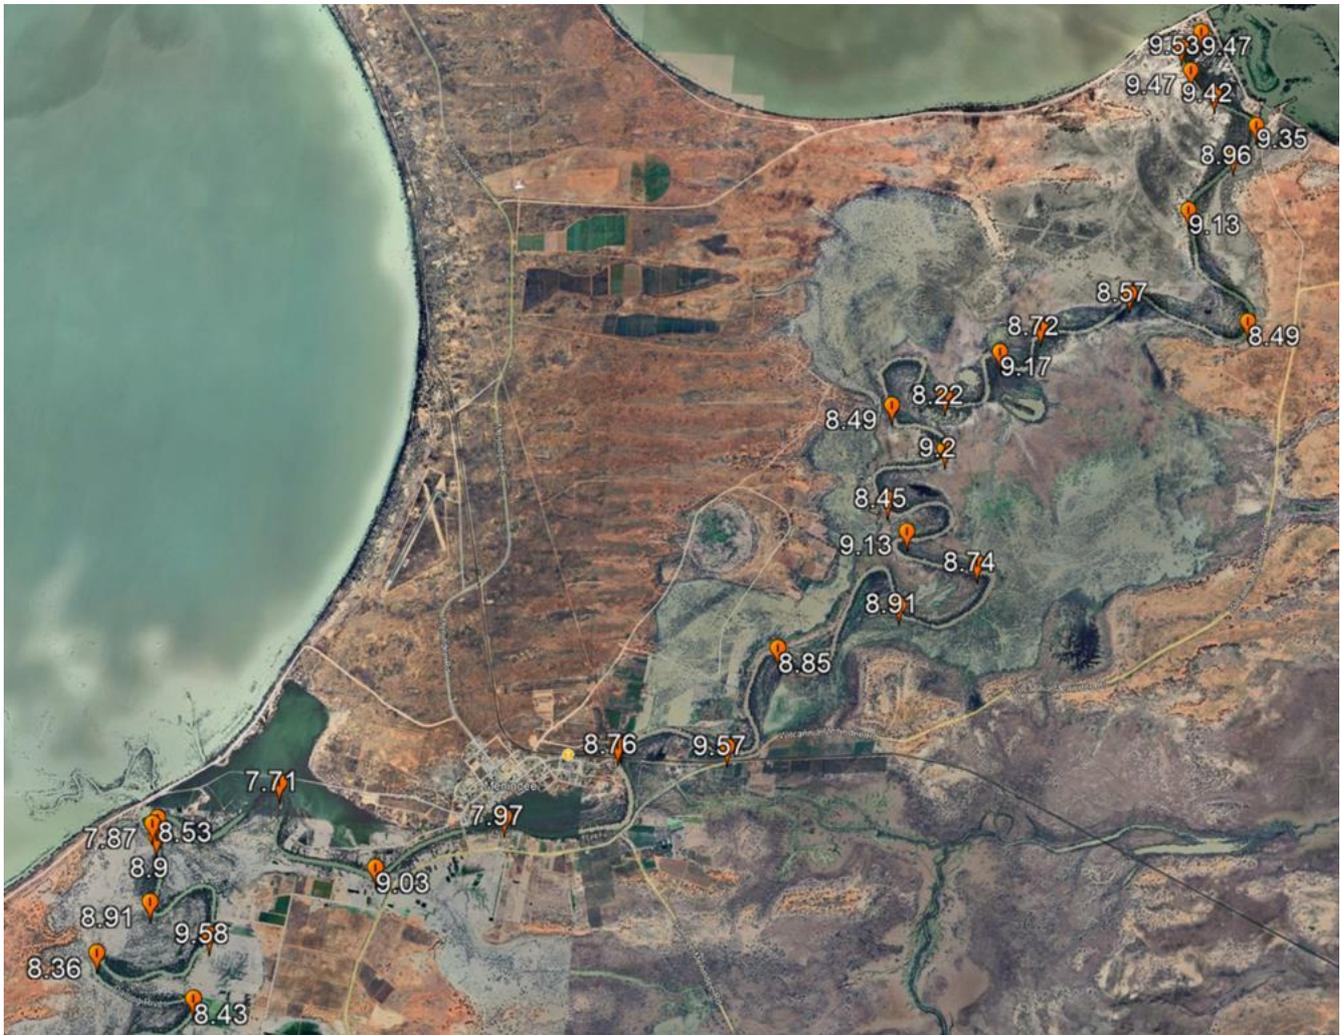
Figure 1 is a Google Earth image showing the location and results from the survey of dissolved oxygen levels down the Darling River on 17 August from Lake Pamamaroo, through Menindee town and down past the junction with the inflow from Lake Menindee. The results show that dissolved oxygen levels were well above critical levels for fish health with the lowest result of 7.71 mg/L recorded between Menindee town and the junction of the Darling River and Menindee Creek. As a

general guide, native fish and other large aquatic organisms require at least 2 mg/L of dissolved oxygen to survive but may begin to suffer if levels are below 4 to 5 mg/L for prolonged periods.

Figure 1: Google Earth image showing dissolved oxygen results (mg/L) from the Lake Pamamaroo outlet to downstream of the Darling River-Menindee Creek junction on 17 August 2023

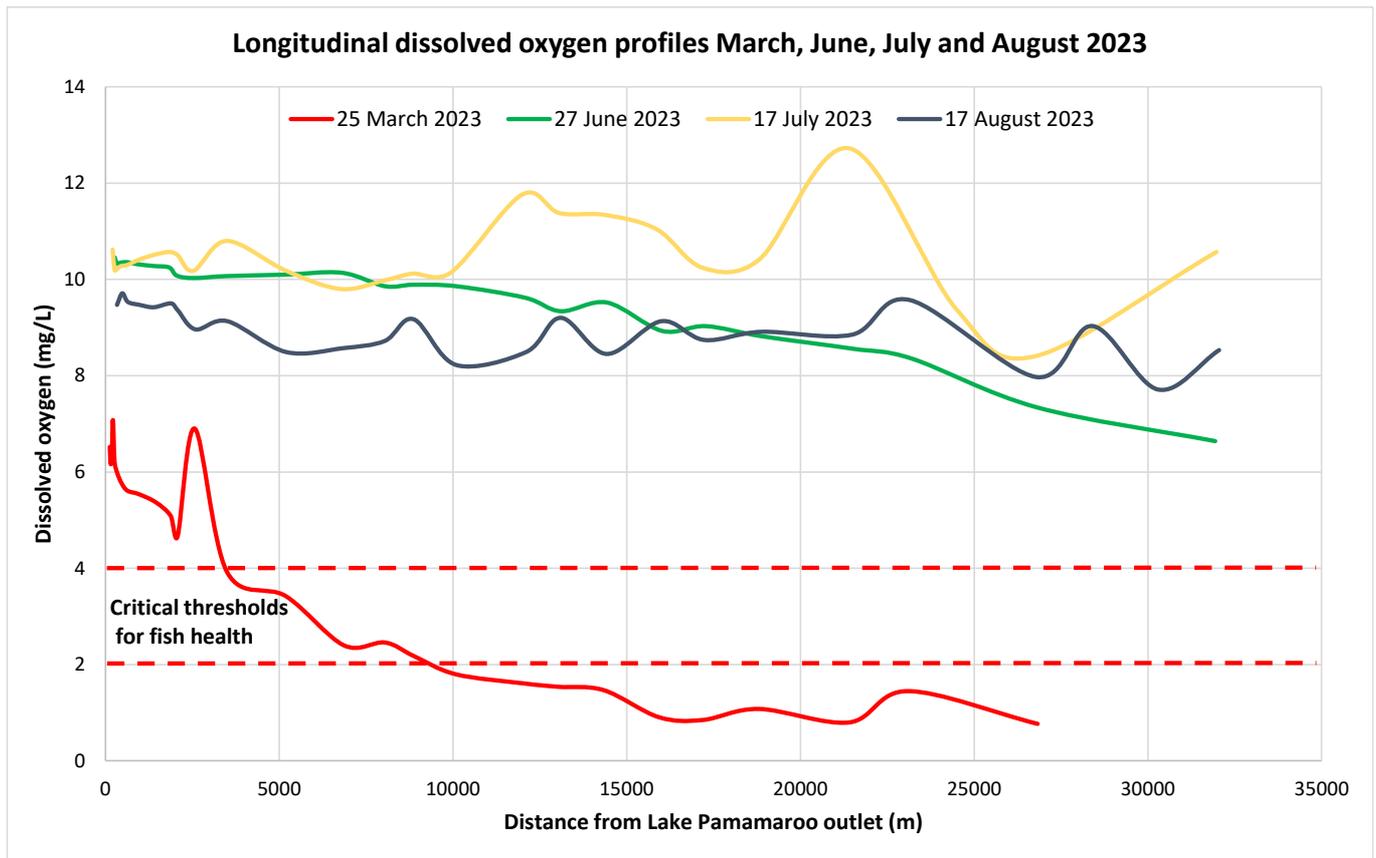
Frequent longitudinal surveys of dissolved oxygen have been undertaken by WaterNSW down this reach of the Darling River. Since the initial survey on 25 March, dissolved oxygen levels have improved and are now remaining above the critical threshold for fish health of 4 mg/L (Figure 2). The most recent survey undertaken on 17 August shows oxygen levels are slightly lower than in June and July. This may be due to showers and overcast conditions on the day the sampling was done. There was not the same amount of fluctuation in dissolved oxygen results down the Darling River in August compared to the results from July.

Figure 2: Comparison of dissolved oxygen results (mg/L) from the Lake Pamamaroo outlet to Menindee town on 25 March and to upstream of the Darling River-Menindee Creek junction on 27 June, 17 July and 17 August 2023

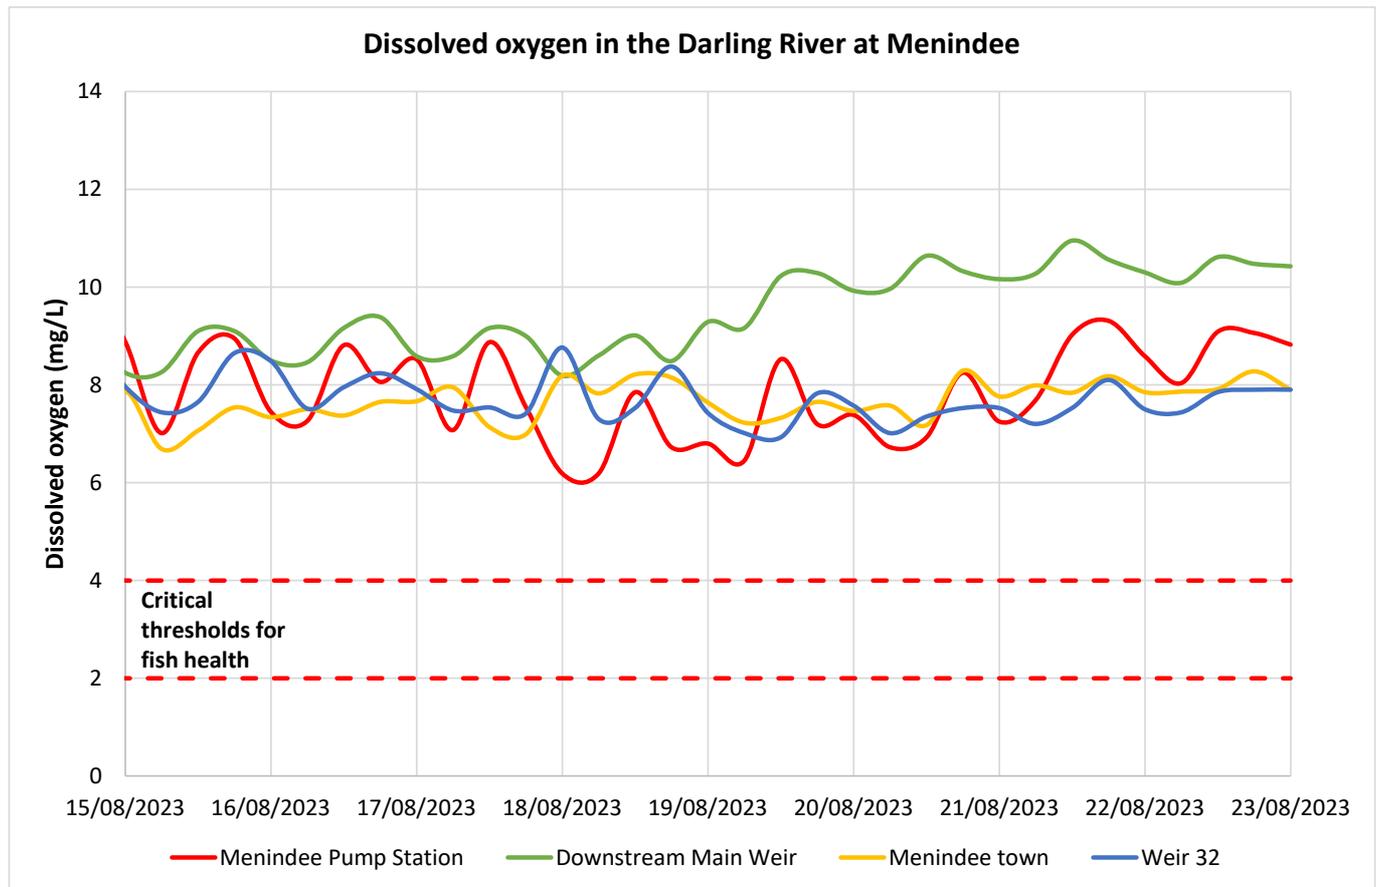
Data from WaterNSW dissolved oxygen sensors downstream of Lake Wetherell Main Weir, Menindee pump station, Menindee town, and further downstream at Weir 32, are shown in Figure 3. These sensors are set at various depths so may not always reflect the readings taken at the water surface. The temporary sensor installed downstream of Lake Wetherell Main Weir is showing the water being released from Lake Pamamaroo is well oxygenated and in the safe range for fish health. Oxygen levels at the downstream of Main Weir site have been improving since the commencement of the flow pulse on 19 August. Dissolved oxygen levels at the two sites near Menindee (Menindee pump station and Menindee town) and further downstream at Weir 32 have been fluctuating from day-to-day, but remaining above the fish health threshold of 4 mg/L. Oxygen levels at the Menindee pump station have also started to improve as the flow pulse makes its way downstream.

Figure 3: Dissolved oxygen (mg/L) in the Darling River at Menindee: Menindee pump station, Menindee town and Weir 32 – 15 to 23 August 2023
