# Murray Darling Basin – water quality and dissolved oxygen results

Multiple agencies are undertaking water quality monitoring to review dissolved oxygen conditions across NSW, identify potential risks to ecological communities, implement mitigating measures and respond to the mass fish death event in the Darling River. This update provides a summary of information collected up to 28 May 2023.

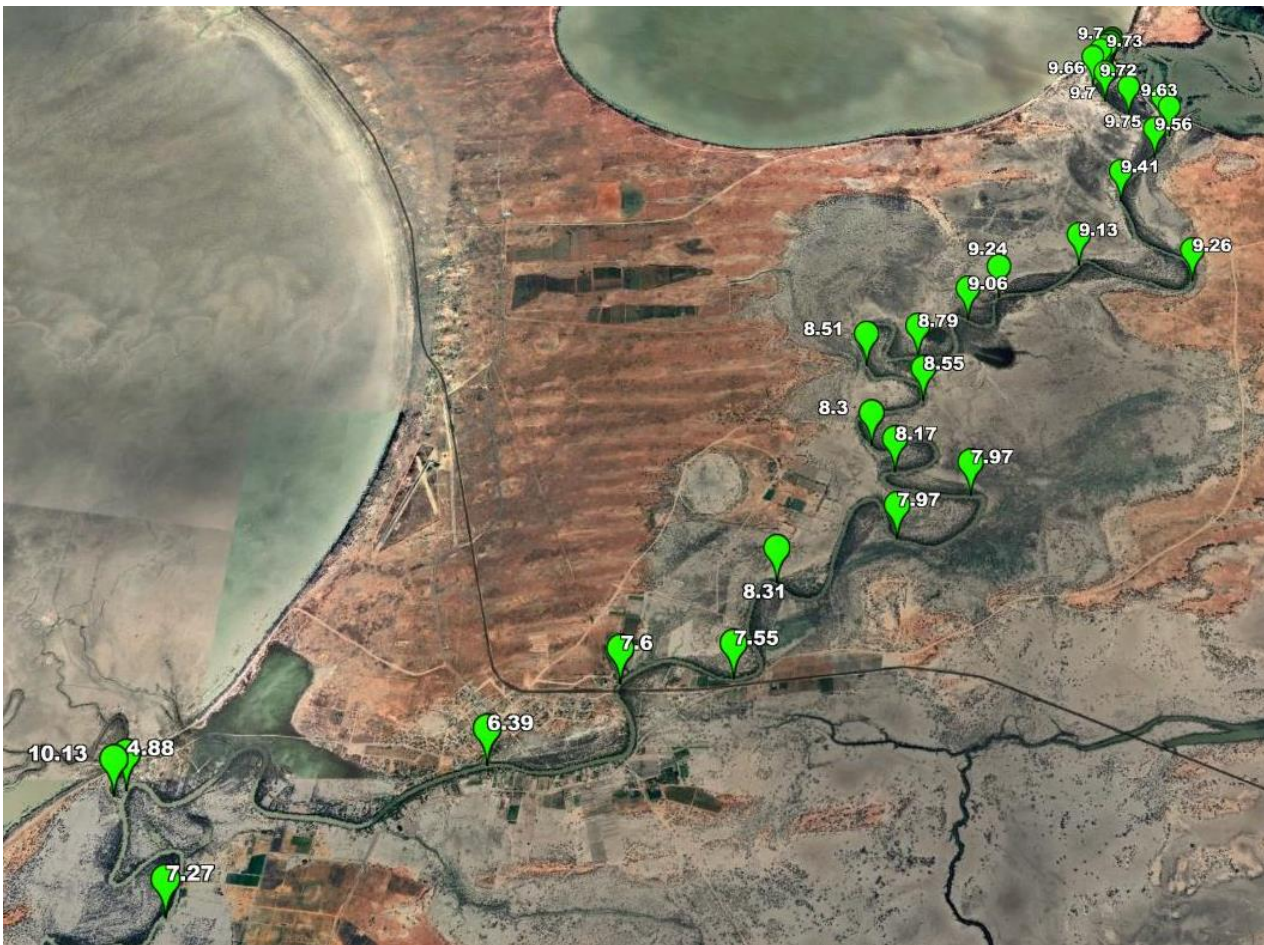
Figure 1 is a Google Earth image showing the location and results from the survey of dissolved oxygen levels down the Darling River on 25 May from Lake Pamamaroo, through Menindee town and down past the junction with the inflow from Lake Menindee. The results show that there was a gradual decrease in oxygen levels with distance down the Darling River. The lowest results were at Menindee township (6.39 mg/L) and immediately upstream of the Darling River-Menindee Creek junction (4.88 mg/L). Dissolved oxygen levels improve again following dilution by the oxygenated water being released from Lake Menindee. As a general guide, native fish and other large aquatic organisms require at least 2 mg/L of dissolved oxygen to survive but may begin to suffer if levels are below 4 to 5 mg/L for prolonged periods.

Figure 1: Google Earth image showing dissolved oxygen results (mg/L) from the Lake Pamamaroo outlet to Menindee Creek on 25 May 2023.

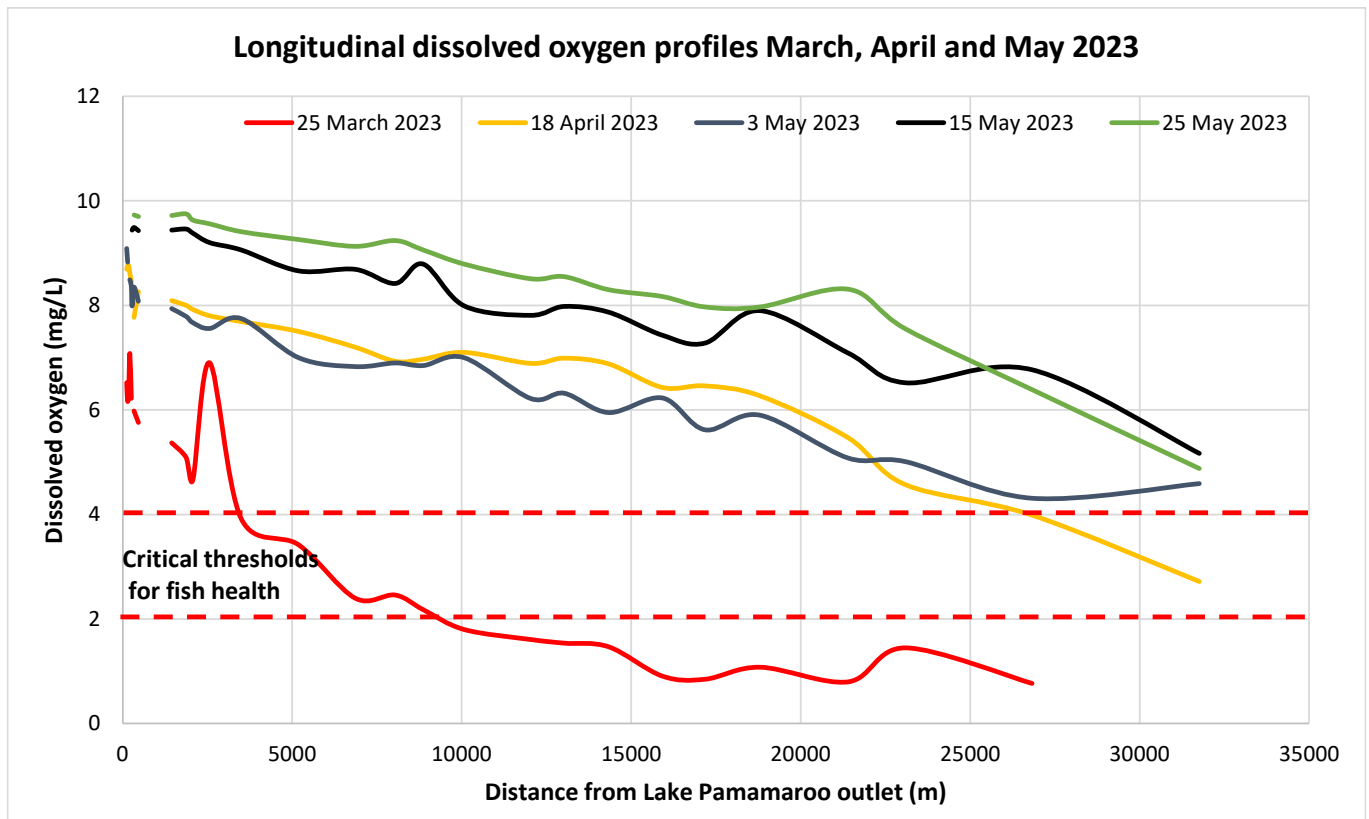
Frequent longitudinal surveys of dissolved oxygen have been undertaken by WaterNSW down this reach of the Darling River over recent months. Figure 2 shows that dissolved oxygen levels have been improving since the initial profile undertaken on 25 March. Dissolved oxygen levels increased through April, but were still below the critical threshold for fish health of 4 mg/L in the vicinity of Menindee town. The most recent survey undertaken on 25 May shows oxygen levels are remaining above 4 mg/L in response to the operational measures in place.

Figure 2: Comparison of dissolved oxygen results (mg/L) from the Lake Pamamaroo outlet to Menindee town on 25 March, 18 April and 3, 15 and 25 May 2023

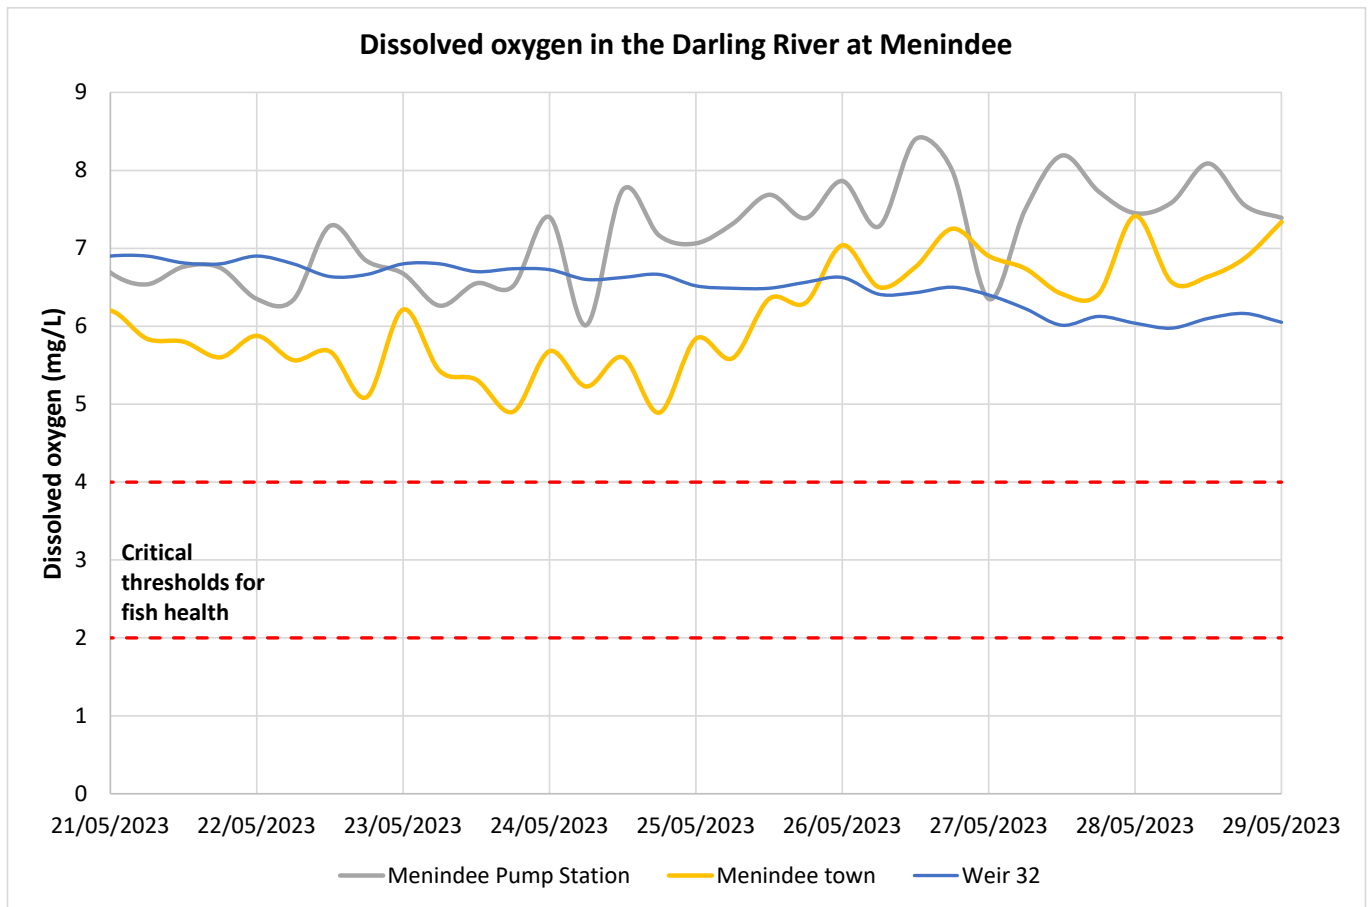
Data from WaterNSW dissolved oxygen sensors at the Menindee pump station, Menindee Town, and further downstream at Weir 32, are shown in Figure 3. These sensors are set at various depths so may not always reflect the readings taken at the water surface. Dissolved oxygen levels at the two sites near Menindee have been fluctuating from day to day over the past week but are remaining above the fish health threshold of 4 mg/L. The readings from Weir 32 show the water is oxygenated and is also providing a refuge area for fish to move into if required.

Figure 3: Dissolved oxygen (mg/L) in the Darling River at Menindee: Menindee pump station, Menindee town and Weir 32 – 21 to 29 May 2023
